Former Plainwell Impoundment Time-Critical Removal Action Weekly Construction Update

Progress Report #28—November 19, 2007

Work Completed: November 8-November 14, 2007

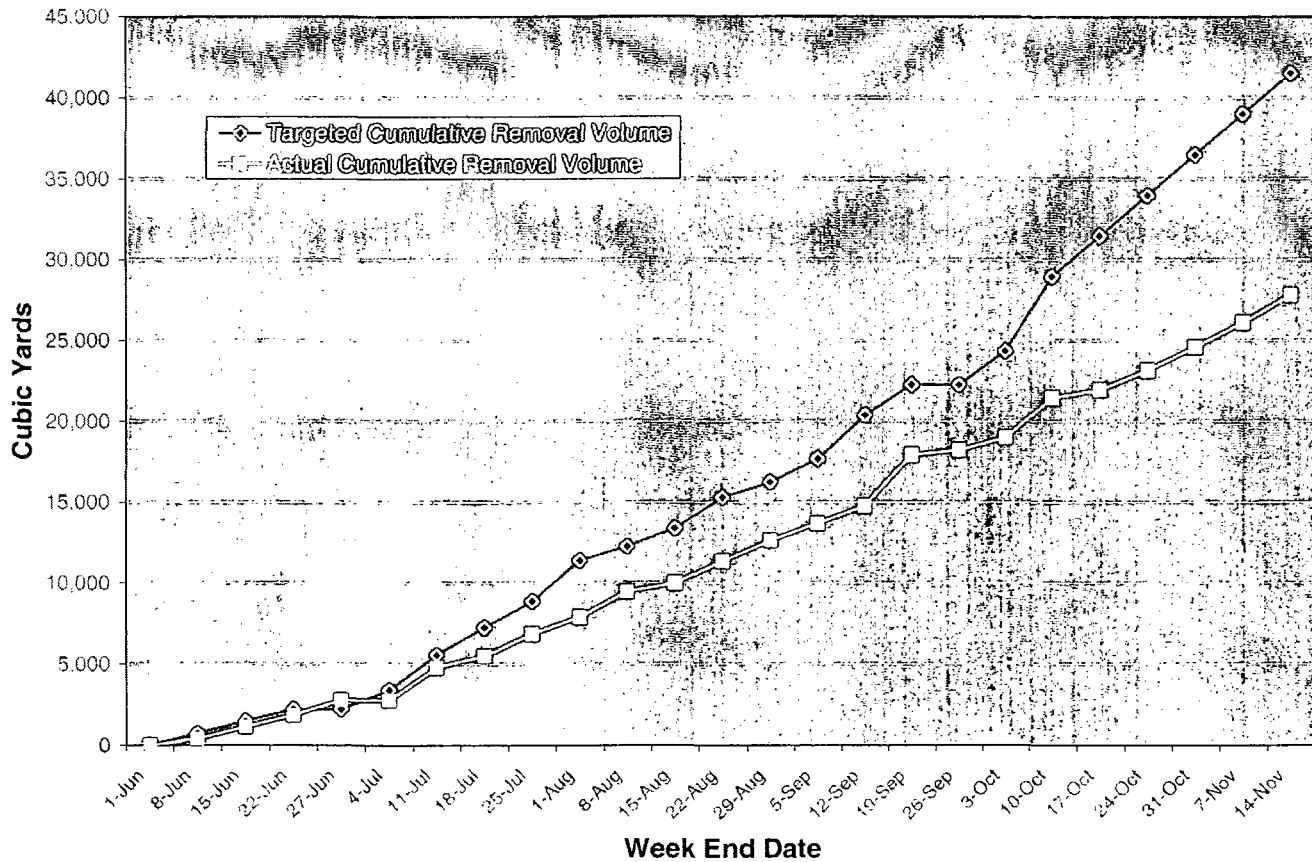
Removal Progress

Targeted volumes are neat and subject to change due to additional excavation done at request of USEPA.

Actual volumes removed are below the targeted volumes potentially due to the conservative estimation methodology used to develop targeted figures and due to the actual topographic conditions encountered at the site, which could result in smaller volumes needing to be removed than originally estimated. The targeted volumes have been increased by 10% to account for additional material that could be removed as a result of over-excavation and additional removal in response to confirmation sampling. Soil/sediment removal activities are on schedule based on the ARCADIS BBLES 4/30/07 Plainwell TCRA Construction Schedule.

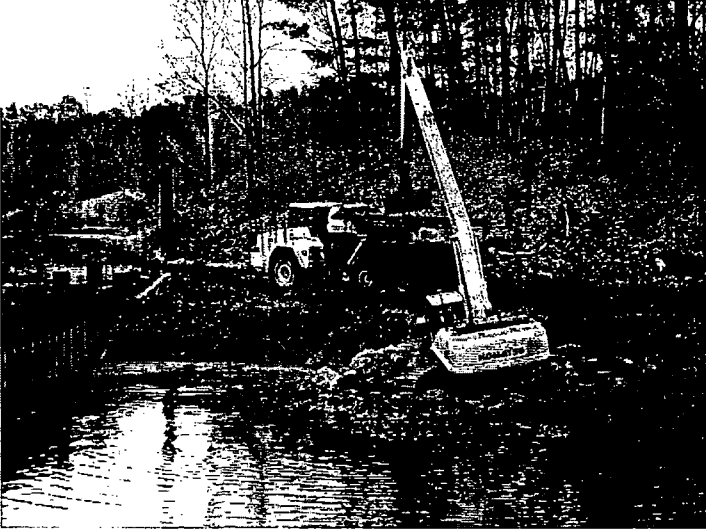
*Loading and hauling sediment from
the Phase 1 Cofferdam Area.*

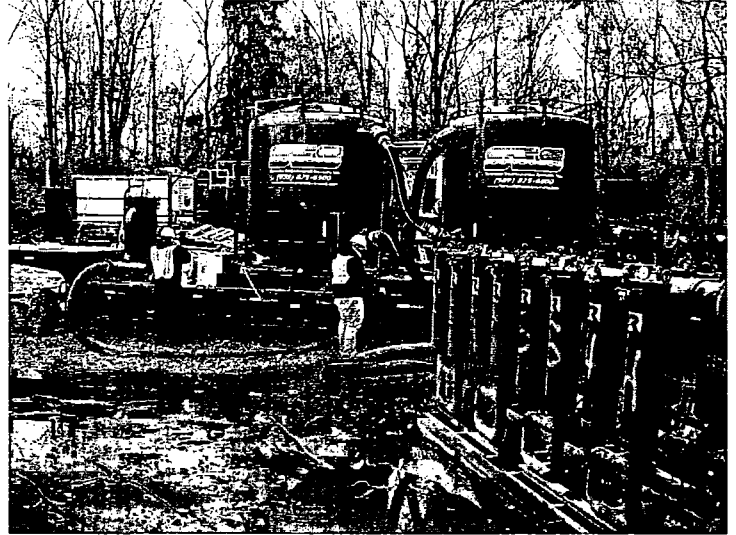
*The 500 gallon per minute treatment system at
the Plainwell Dam.*

- Began excavating and grading embankment material near the Plainwell Dam. Began demolition of the former powerhouse's concrete foundations.
- Completed dewatering and operating the 500 gallon per minute (gpm) treatment system at the Phase 1 Cofferdam Area. Began decontamination and removal of the 500 gpm treatment system.

- Continue excavating and grading of embankment material near the Plainwell Dam. Continue concrete demolition of former powerhouse foundations.
- Continue decontamination and removal of the 500 gpm treatment system.

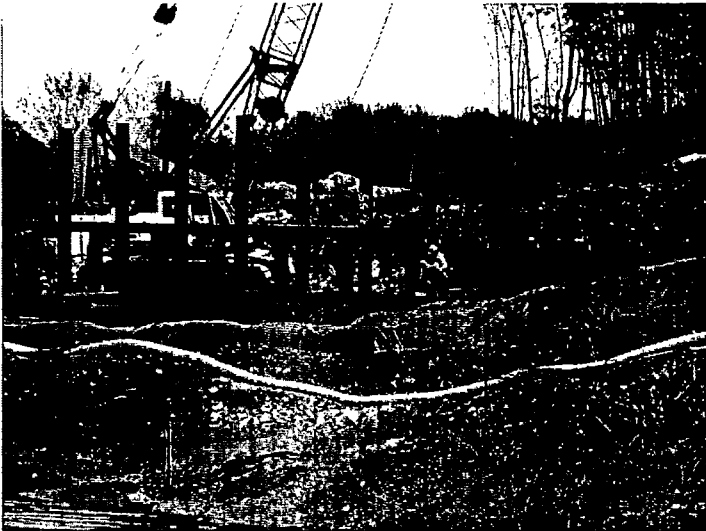
Installing beams and decking at the water control structure.

- Continued installing cross-bracing, beams, and decking at the water control structure.
- Continued turbidity monitoring of the Kalamazoo River to support removal activities.

- Continue installing a catwalk, stop logs, and concrete at the water control structure.
- Continue turbidity monitoring of the Kalamazoo River to support removal activities.

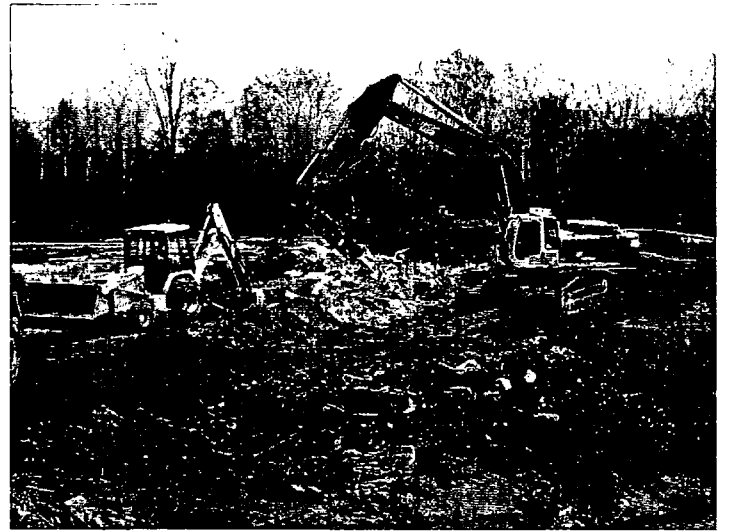
*Breaking concrete from the former powerhouse at
the Plainwell Dam.*
